## TEST REPORT

No.: SZIN2607001423ML02\_EN

Sample Name : Nerezová lanková sieť  
Product or Lot No. : Nerezová sieť s okom 40x40mm  
Material and Mark : Stainless Steel AISI 316  
Other Information : Distributor: Kovian s.r.o.

Tensile breaking load test:

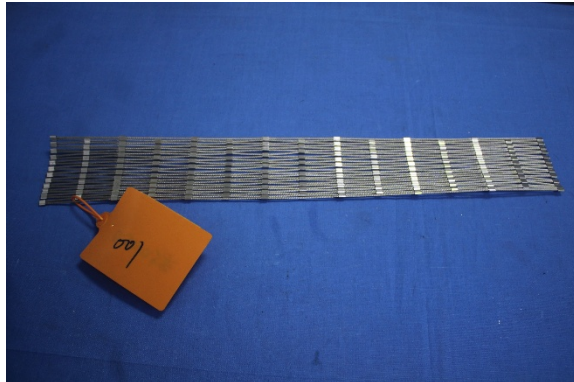
Before test

Step 1. Fix the sample on the test equipment,

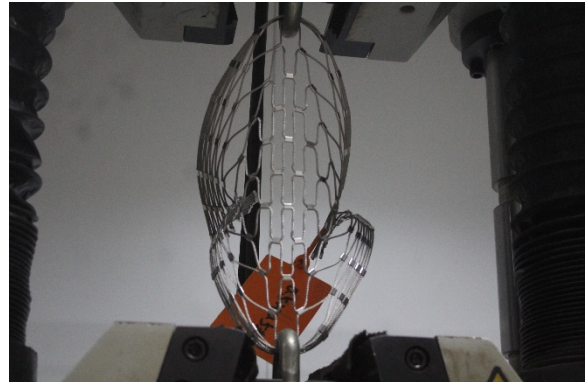
During test

Step 2. Loading at the rate of 20mm/min until the specimen's fracture,

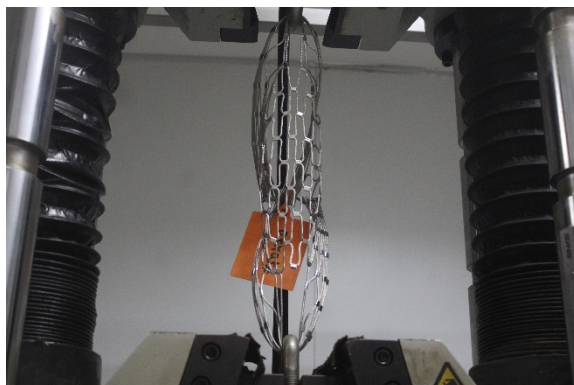
After test -1

| Sample | Maximum force (kN) | Fracture location |
|---|---|---|
| 001 | 2.350 | See test photo |
